# Improving our understanding of ship side thruster forces on existing armoured berths through physical modelling of prop-wash

## Abstract

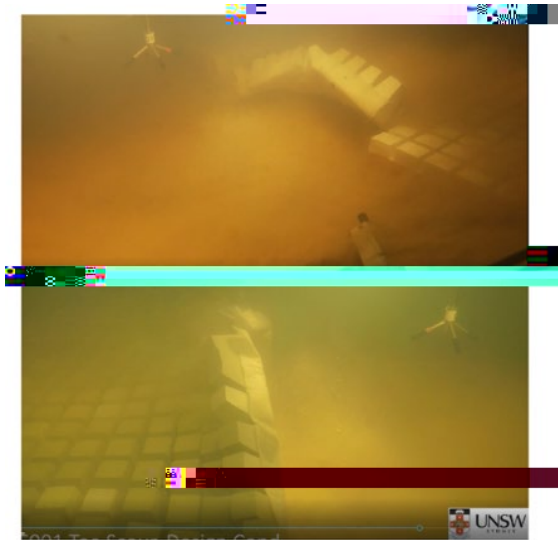
Figure 10 ACMs moving during testing

(a) Underwater video footage showing flapping of leading edge of ACMs

(b) 3D FARO scan post test

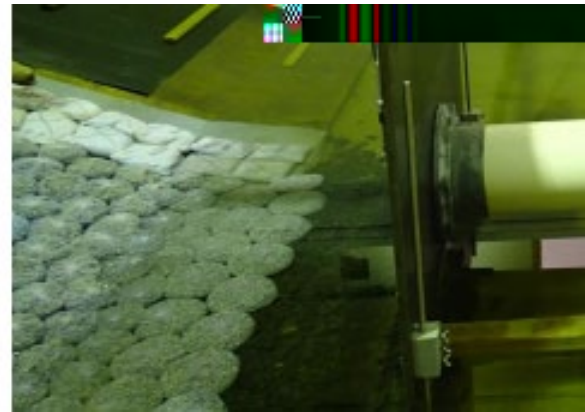
Rock bags were usually stable for the conditions tested (Figure 11). As per rocks, the jet pushed the bags up and into the slope resulting in greater stability than originally expected. The bags were susceptible to jets at angles. Also being a single layer, if a bag was moved then large sections of the slope could become unstable. The long-term integrity of the bag fabric was not assessed.

Figure 11 Rock bags on revetment slope in front of bow thruster setup
